Fw 190D

Walk Around Number 10
squadron/signal publications

By E. Brown Ryle and Malcolm Laing

Focke-Wulf Fw 190D-9

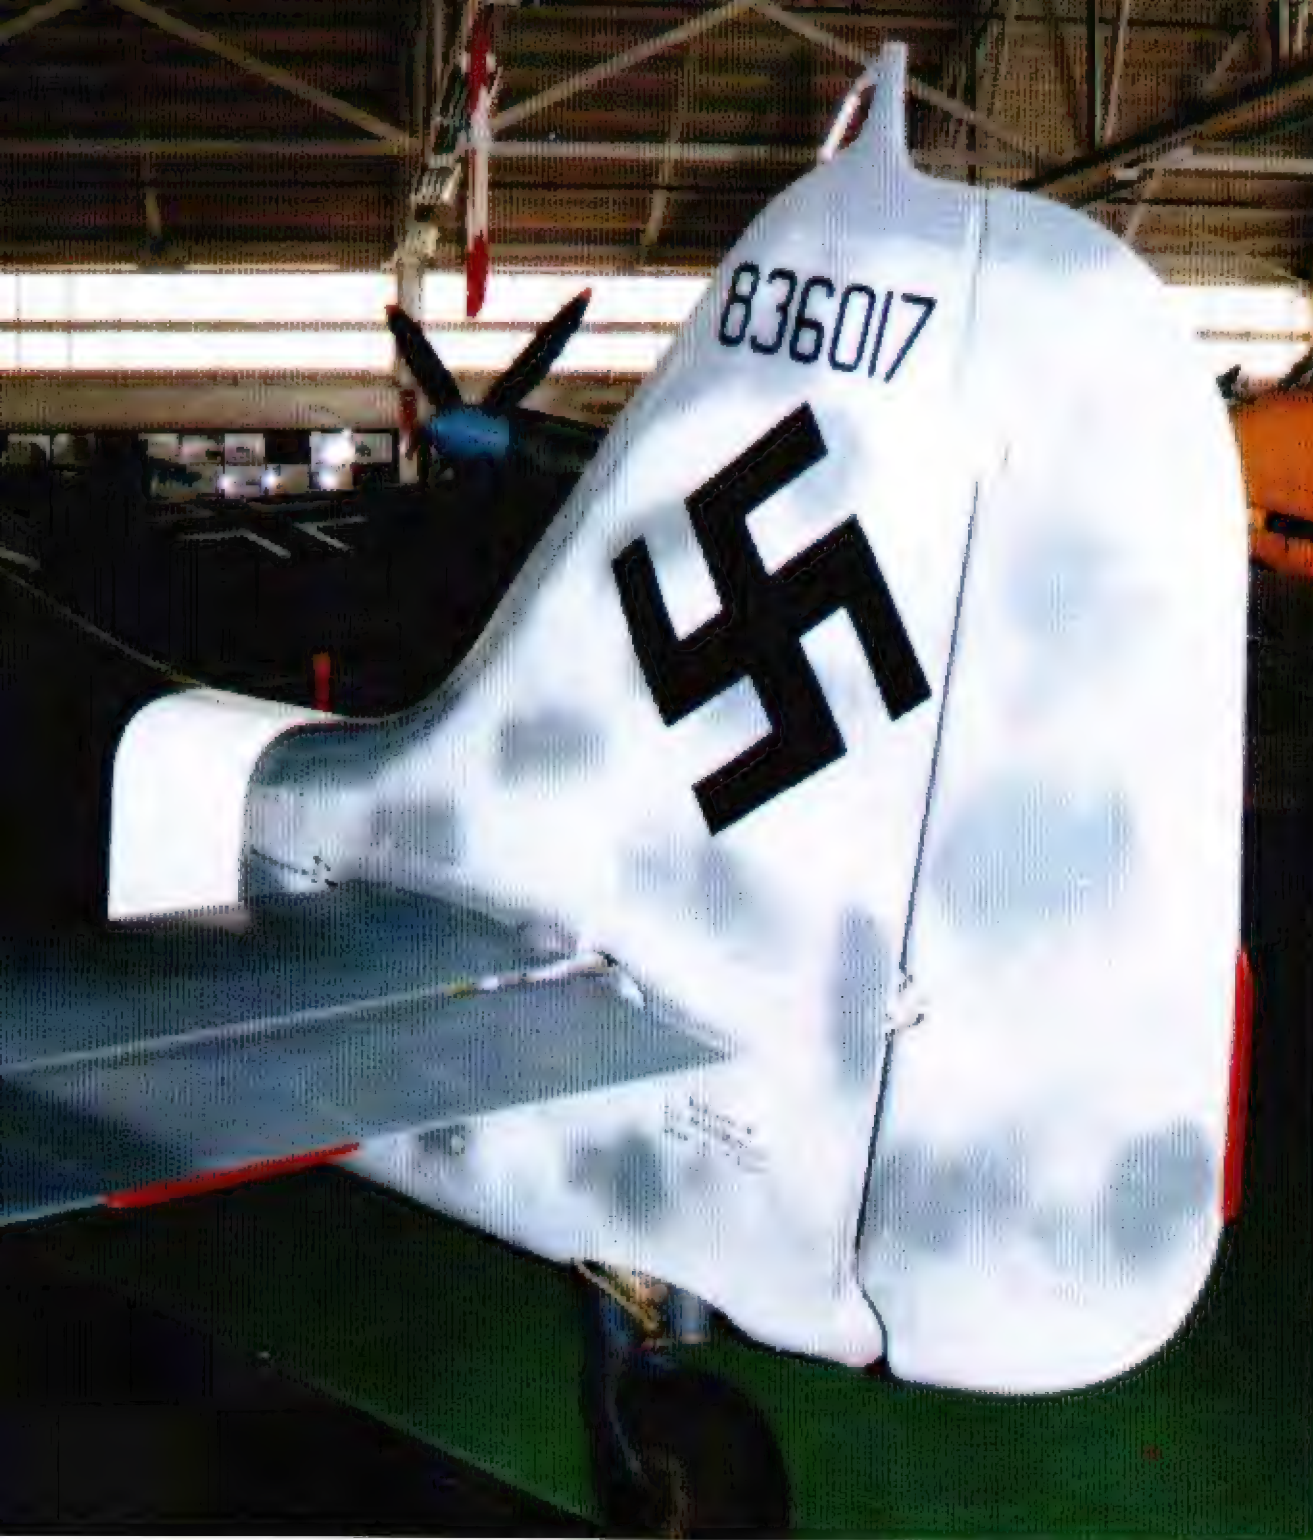
(Above) The tail assembly of Fw 190D-13 has the Work Number, 836017, positioned on both sides of the tail. Often the entire Work Number appeared on the port side, with only the last three digits being repeated on the starboard side. The antenna post on the vertical stabilizer has been replaced and the rudder is a replica. (Author: Ryle)

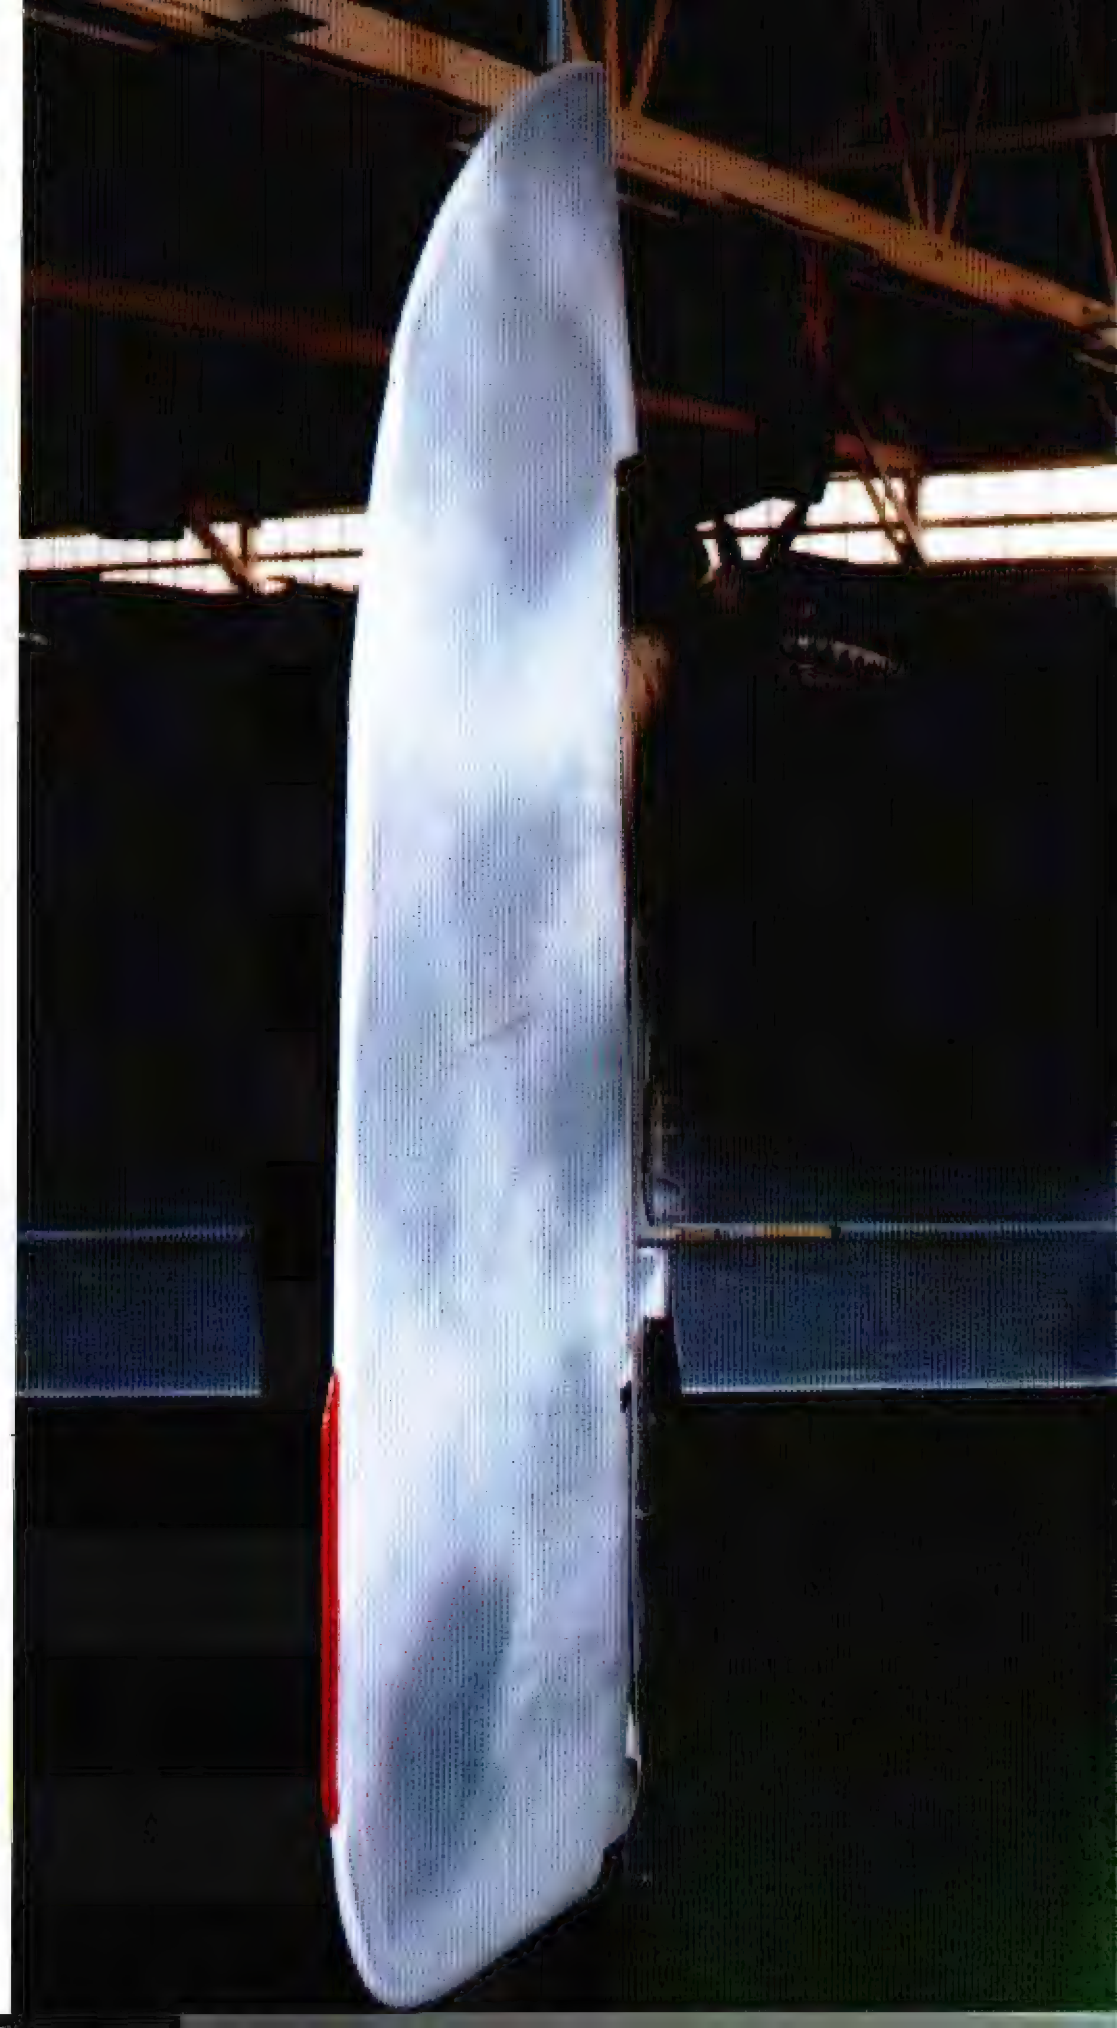
(Right) The replica rudder at full left deflection. The Fw 190 rudder had a cloth covering stitched to a heavy metal frame. The fixed metal trim tab is painted red. (Author: Ryle)

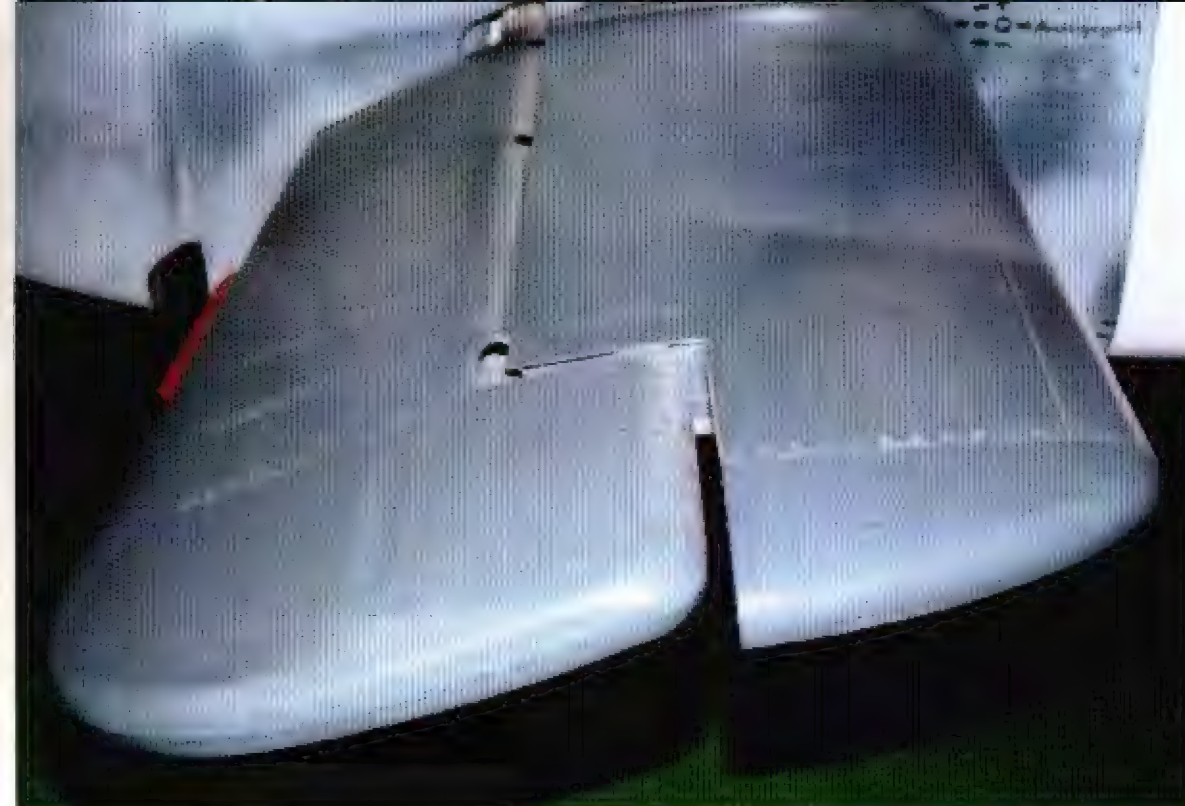
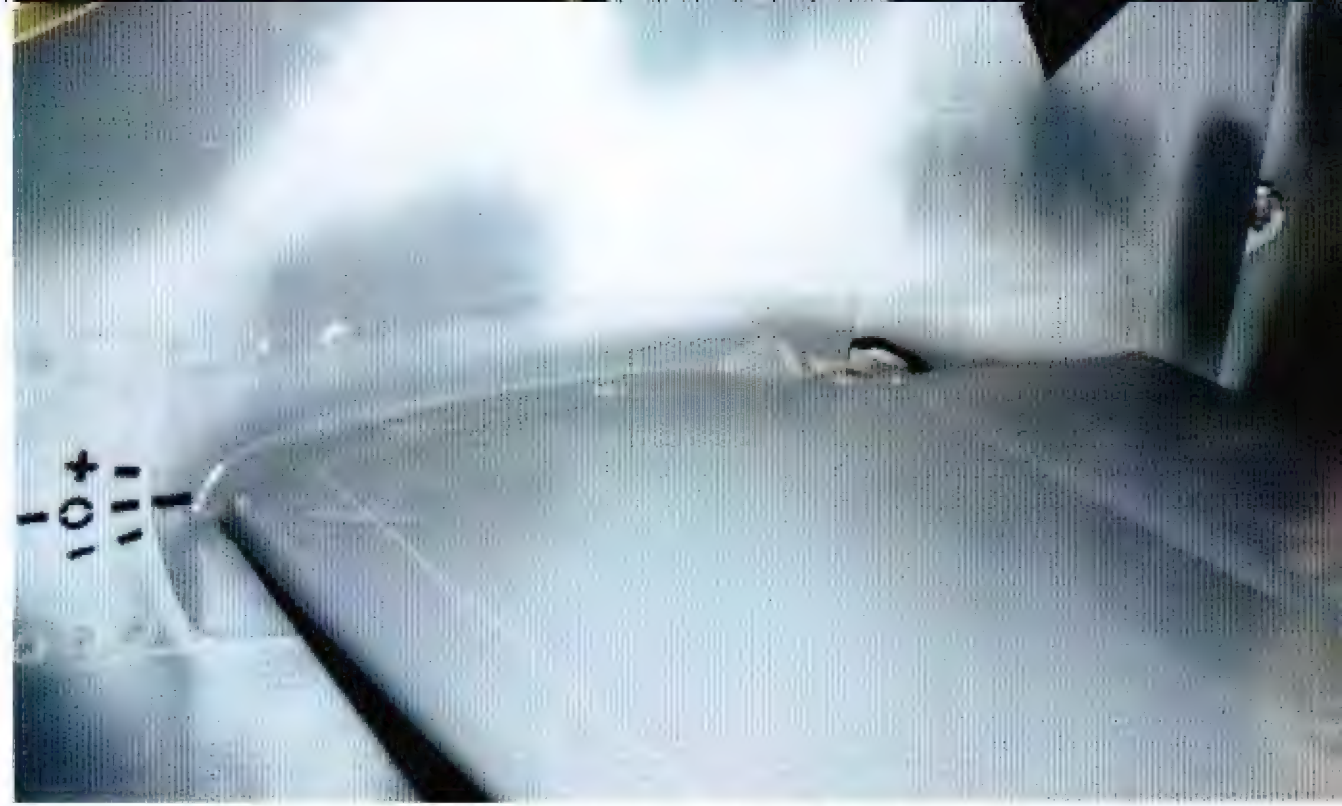
(Above and below) The replica horizontal stabilizer with the elevator in the full up and full down position. The horizontal stabilizer is all metal construction, while the elevator, like the rudder, is cloth over metal frame construction. The cloth is stitched to the elevator's frame, taped over, then the assembly is painted the same as the other parts of the aircraft. However, the difference in light reflection between the cloth covered parts and the metal parts almost made the fabric surfaces look like they were a different color. (Author: Ryle)

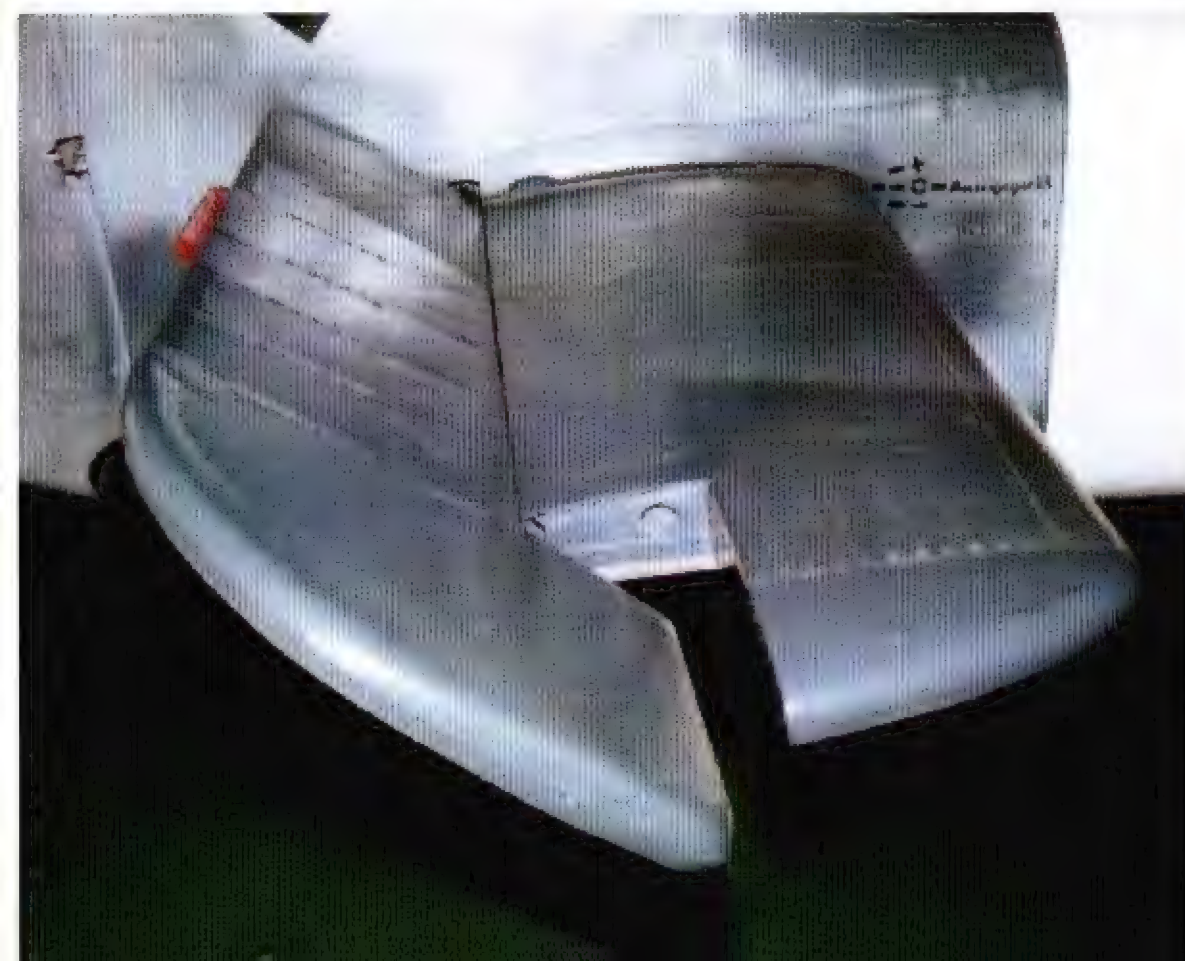
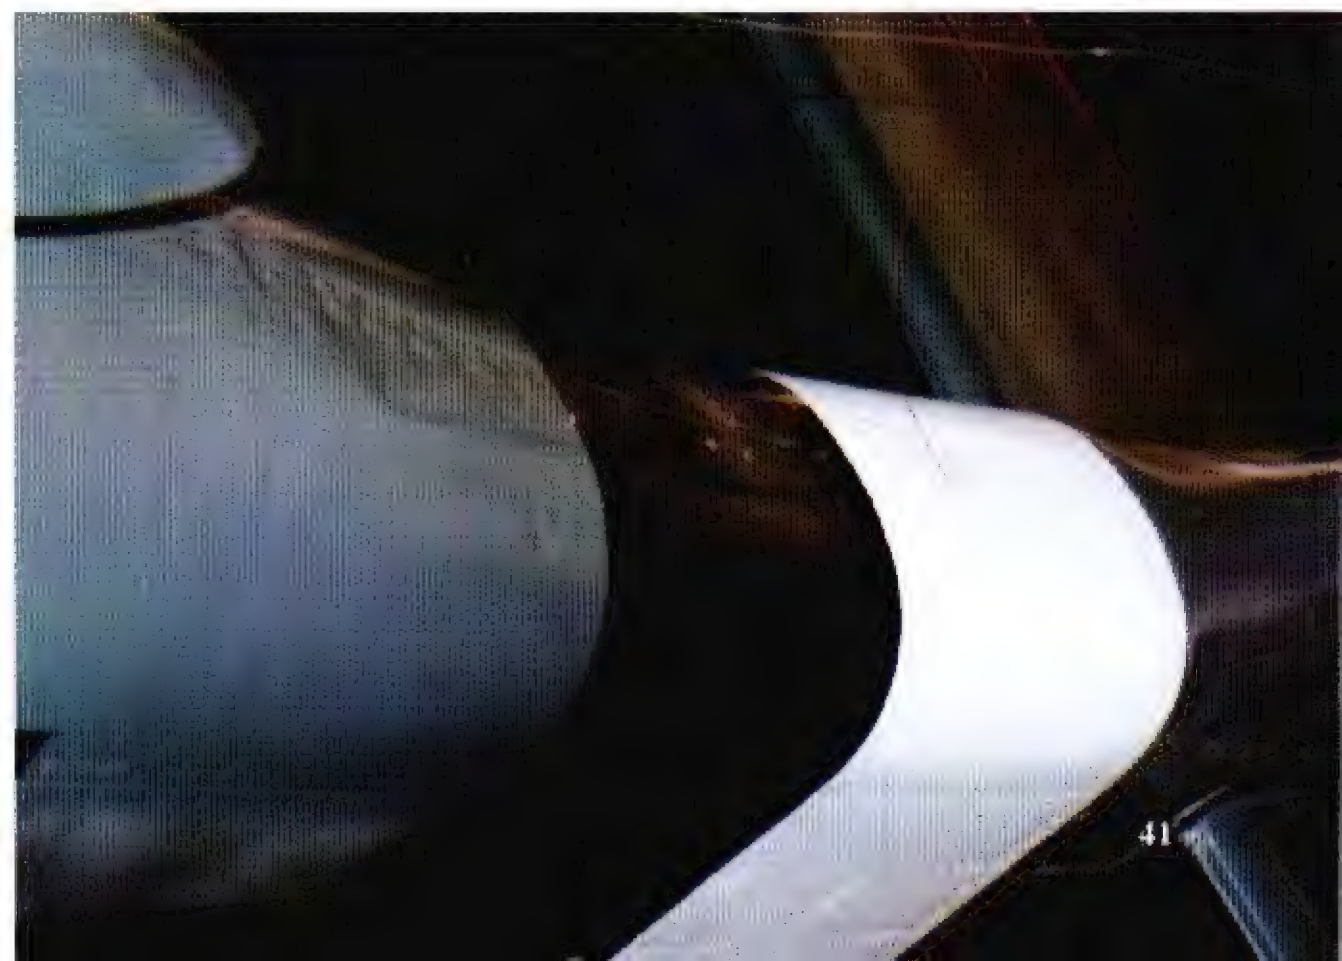
The + 0 - markings on the fuselage indicates the "horizontal stabilizer incidence" which could be adjusted by the pilot from +4 degrees to -1 degree, to compensate for changes in the aircraft's trim. A small electric motor in the tail actuated changes. The normal position is 0 (which is actually +2 degrees relative to the fuselage thrust line). (Author: Ryle)

The fuselage extension plug is painted with a Black and White Defense of the Reich band. The entry point of the vertical antennawire can be seen in the Black band. (Author: Ryle)

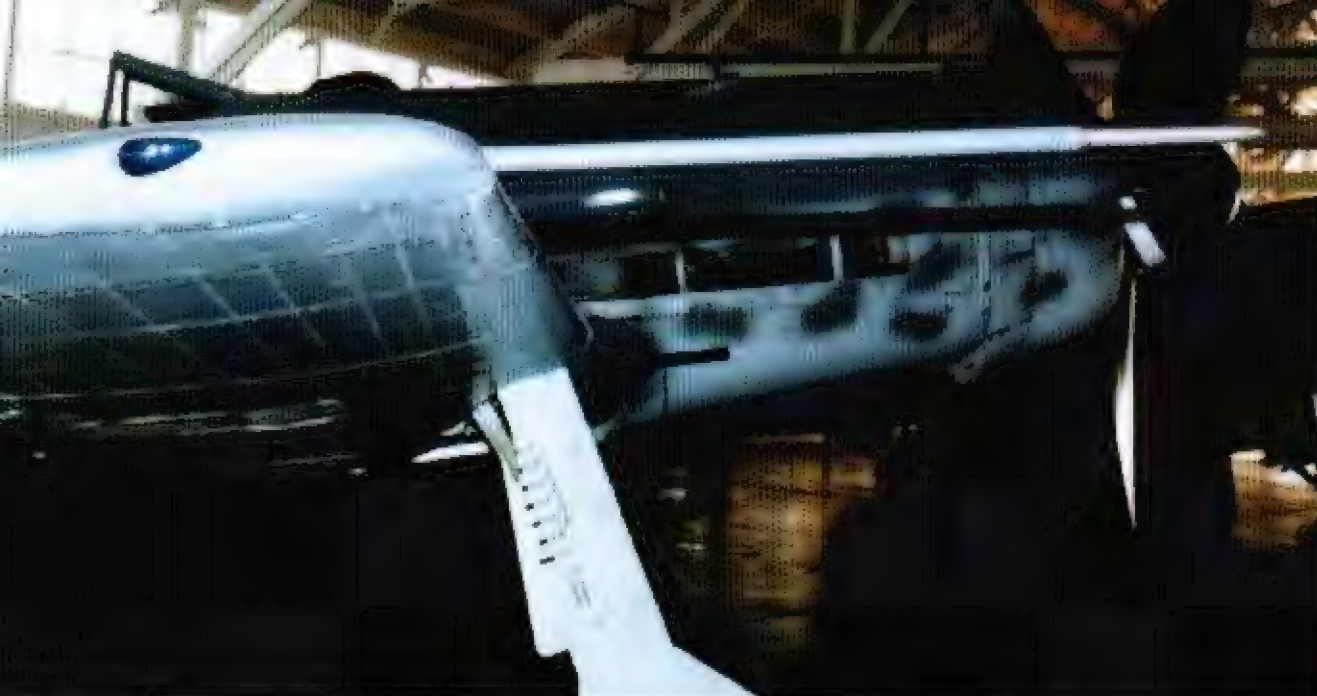
The starboard wing tip carried a Green navigation light. The angle of the pitot tube in relation to the angle of the wing is slightly downward. The tip of the pitot tube is not painted, but left in natural metal. (Author: Ryle)

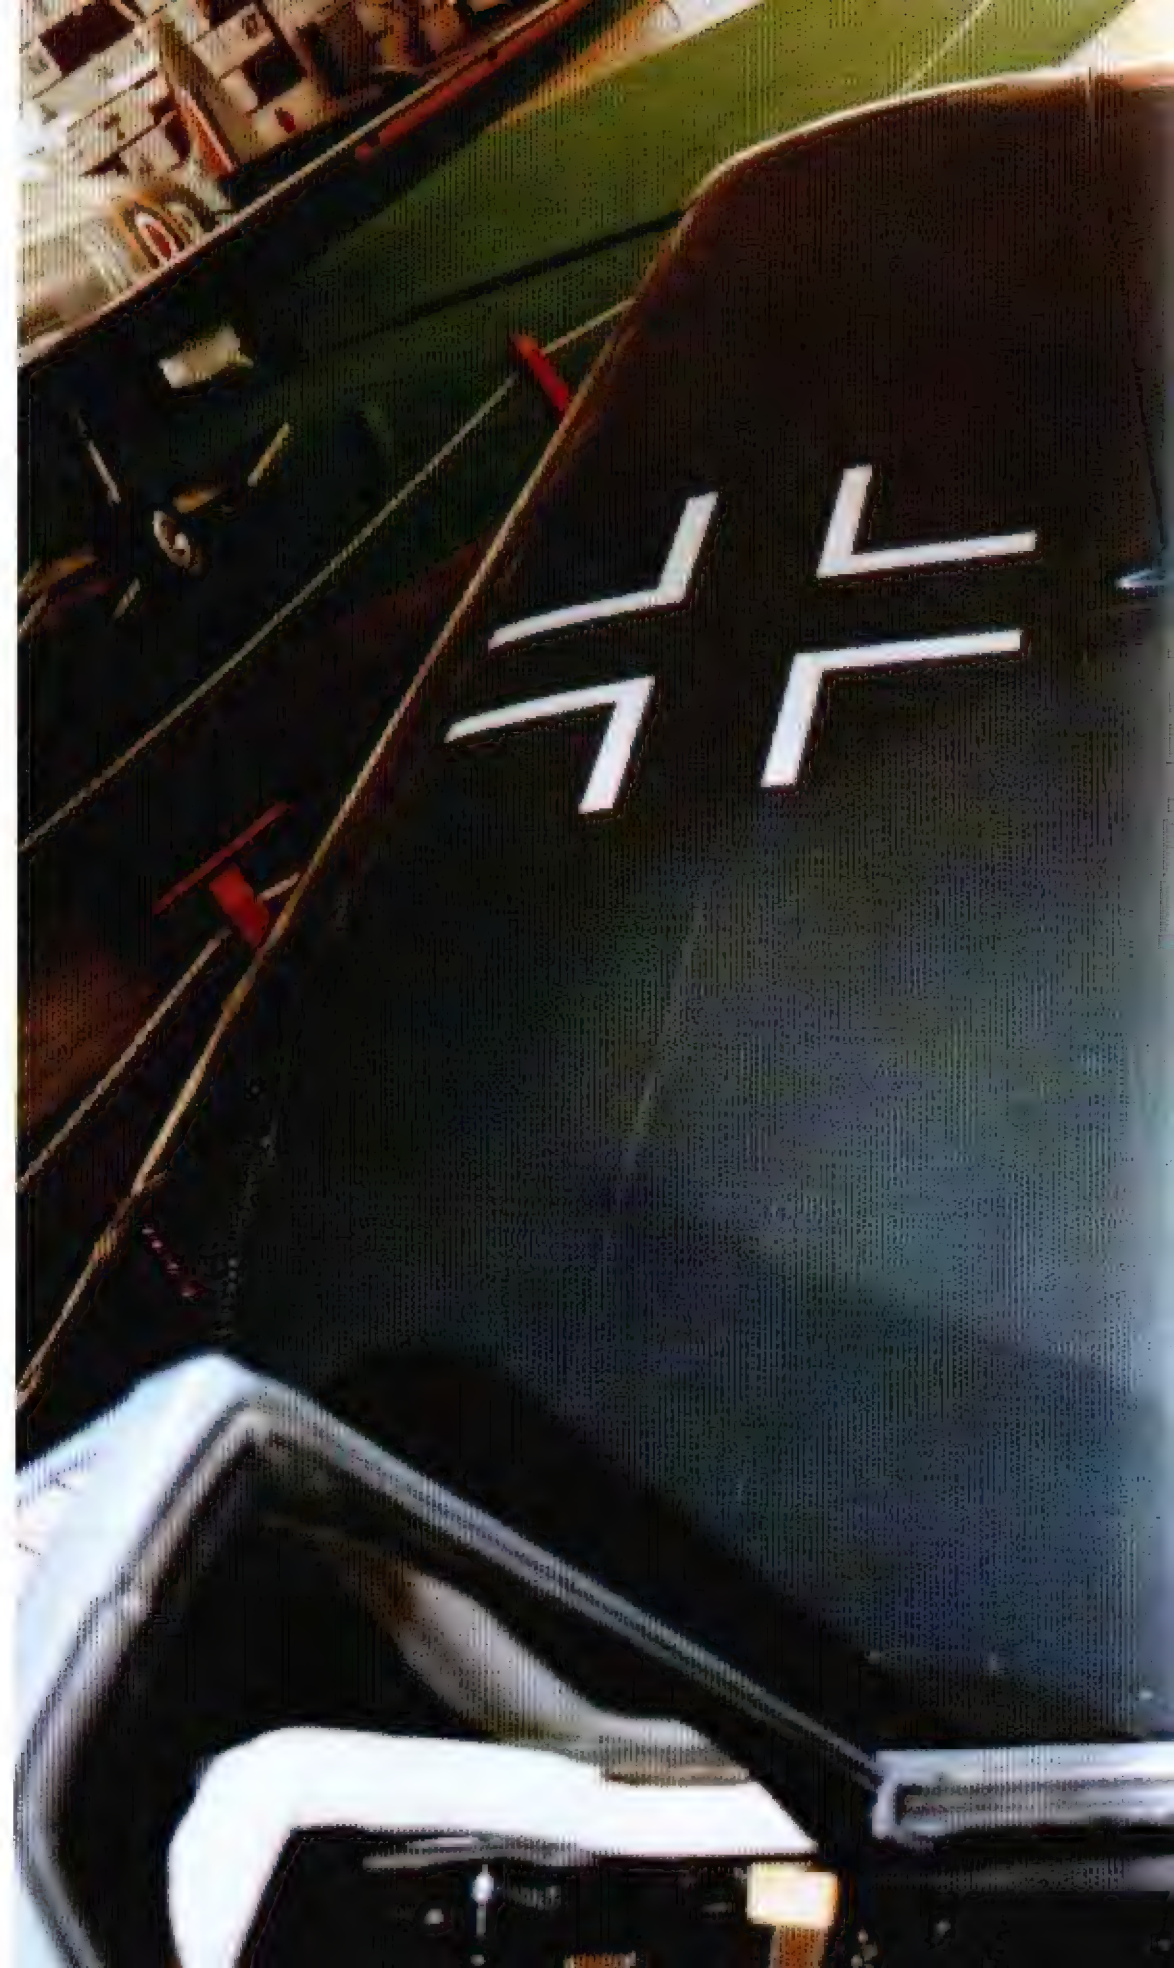
The red and white striped visual landing gear position indicator was on both wings. This small rod was attached to the main landing gear brace and protruded through the wing top of both wings when the gear was lowered, providing the pilot with a mechanical/visual indication that the landing gear was down. The attachment screws for the wing leading edge panels stand out along the wing panels. (author: Ryle)

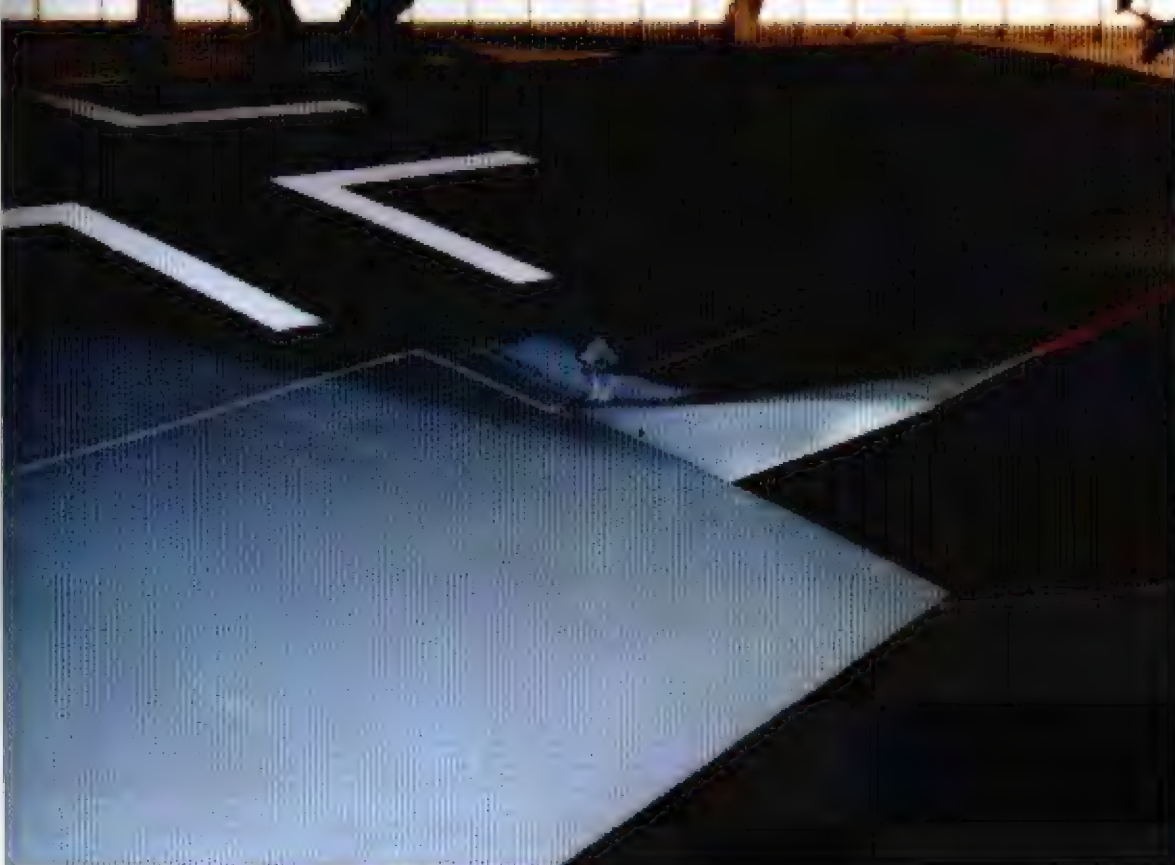
The starboard wing aileron in full up and in full down position. The aileron is cloth over a metal frame the same as the rudder and the elevators. Painted red, the metal trim tab is positioned quite close to the inboard edge of the aileron. (Author: Ryle)

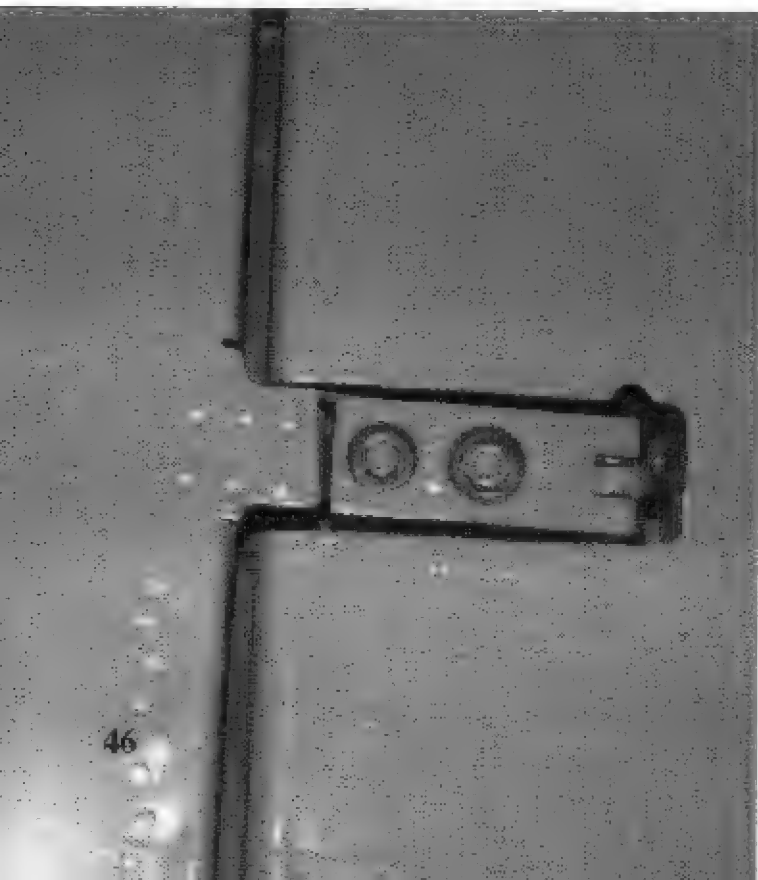
The Center aileron attachment bracket on the bottom of the wing. The small half moon cut-out in the aileron is to allow access to that part of the bracket. (Author: Ryle)

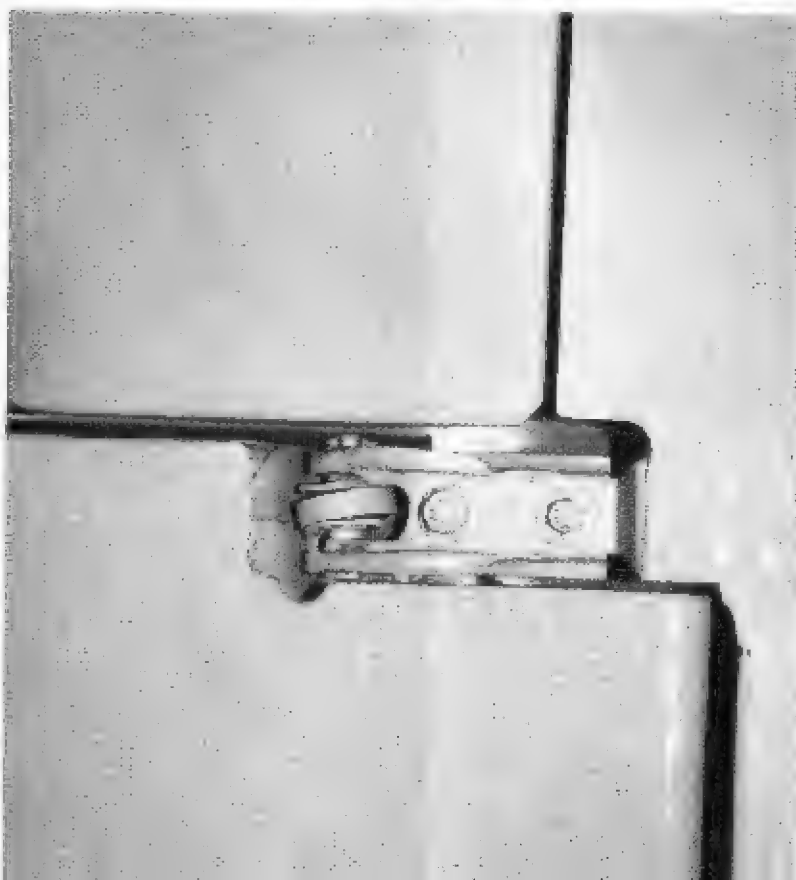
The inboard aileron attachment fitting on the bottom of the wing. The trailing edge of the wing and the leading edge of the aileron and bracket do not have a tight fit. This type of fit is not uncommon on Fw 190 wings. (Author: Ryle)

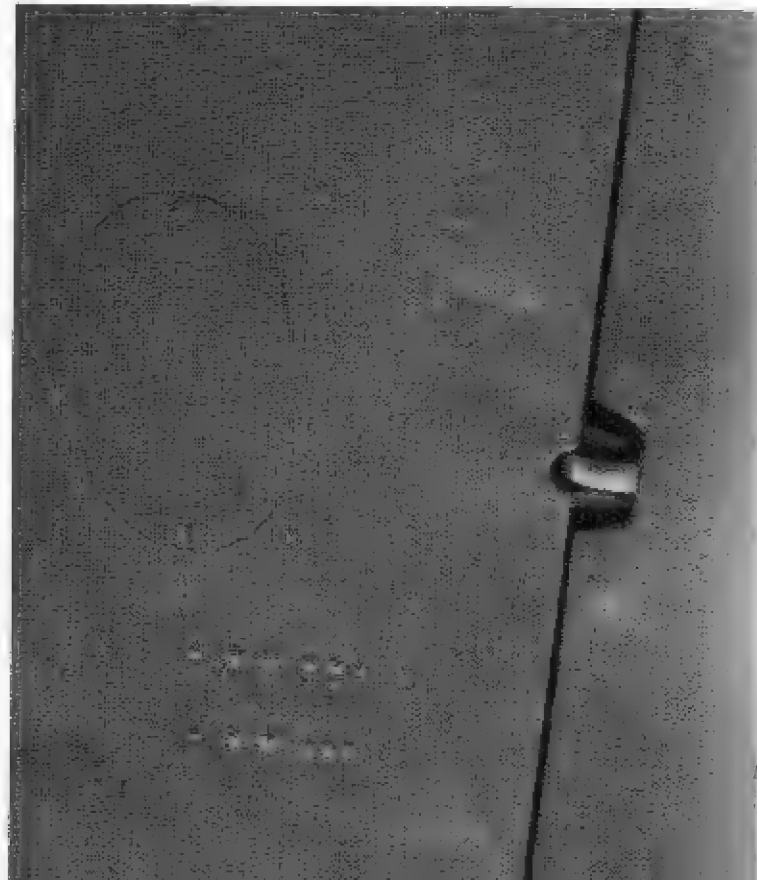
The flap pivot arm located on the leading edge in the center of the flap. The wing edge requires a small cut-out to allow clearance of the pivot when the flap is lowered. (Author: Ryle)

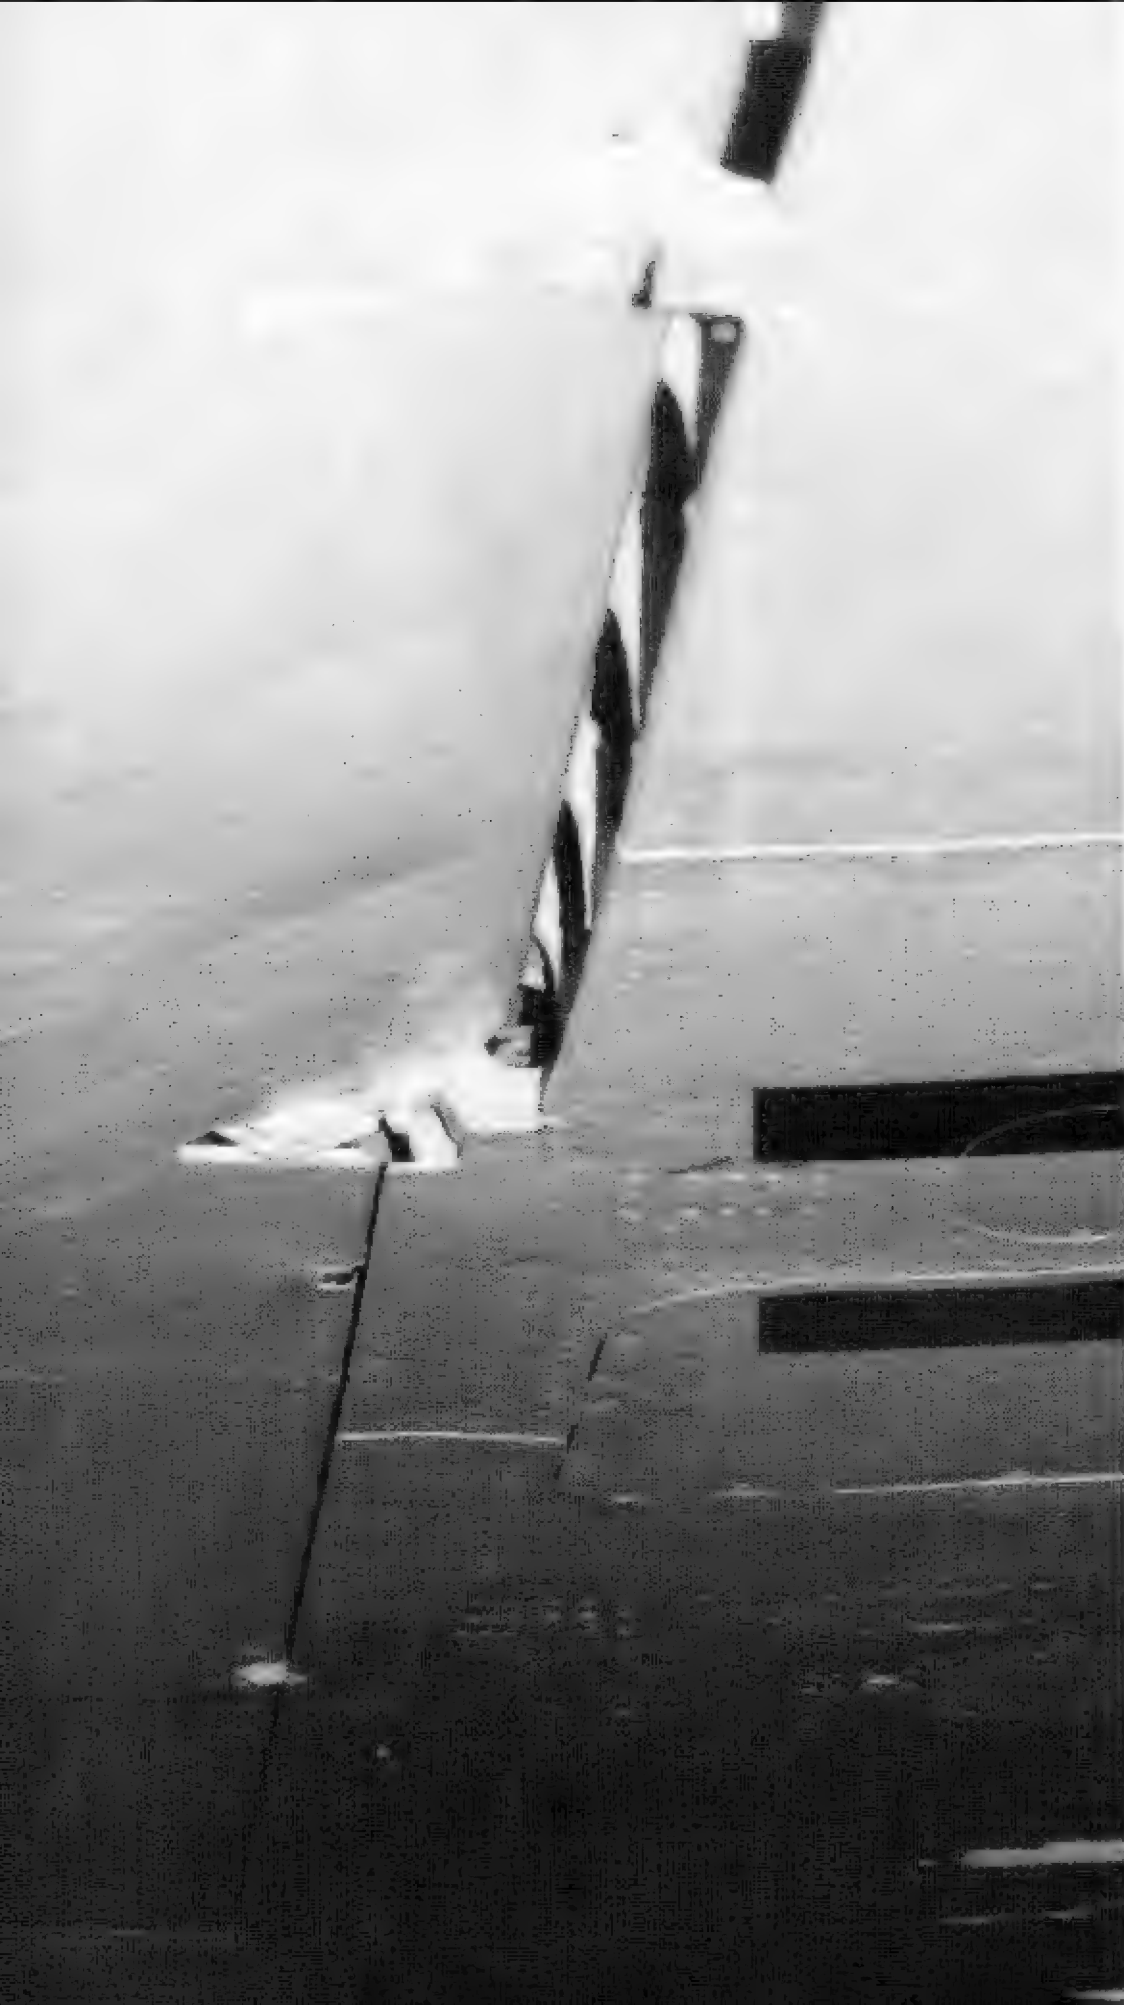
The lower outboard gun bay access panel on the starboard wing. These panels were originally used on the earlier Fw 190A to access the outboard wing mounted cannons. The outboard cannons were seldom installed on the Fw 190D, and this panel acted as a no more than a portion of the wing. (Author: Ryle)

(Left) The starboard wing flap is in the full up position and the aileron is in the full down position. The internal wing area behind the aileron is heavily reinforced with stiffeners. (Author: Ryle)

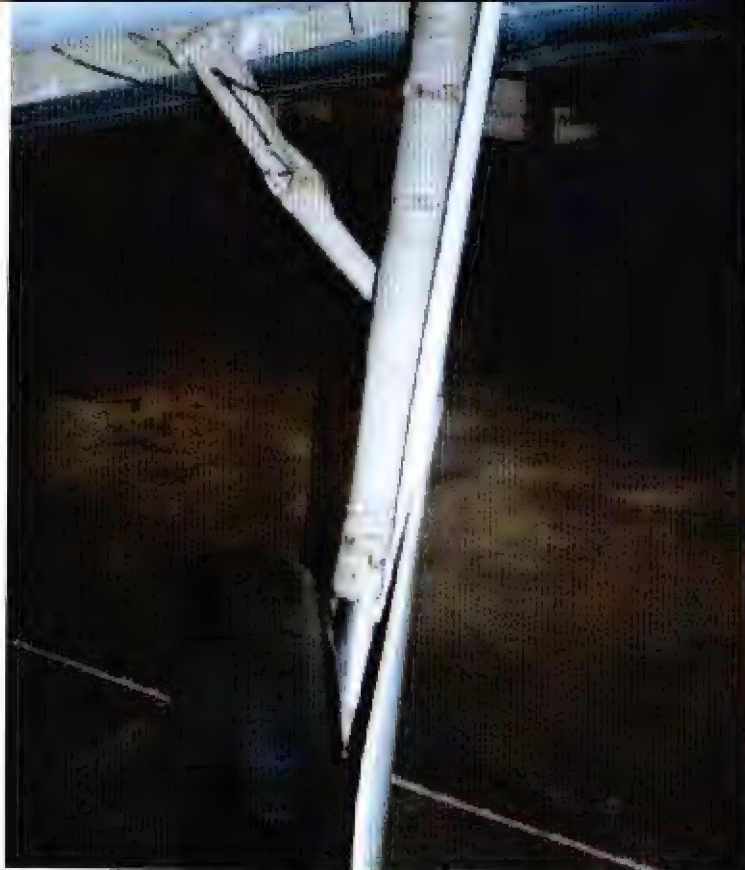
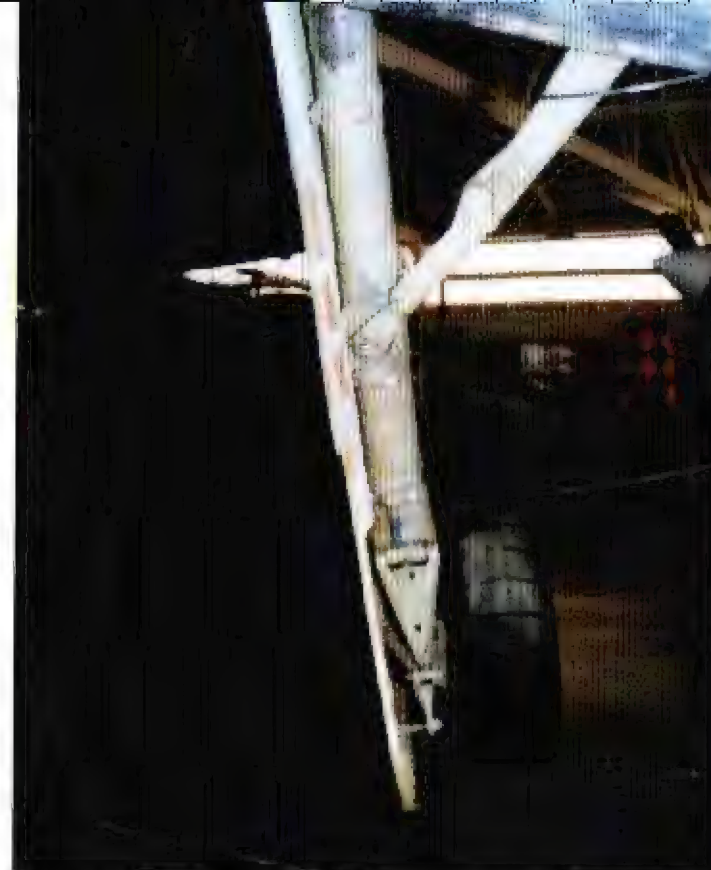
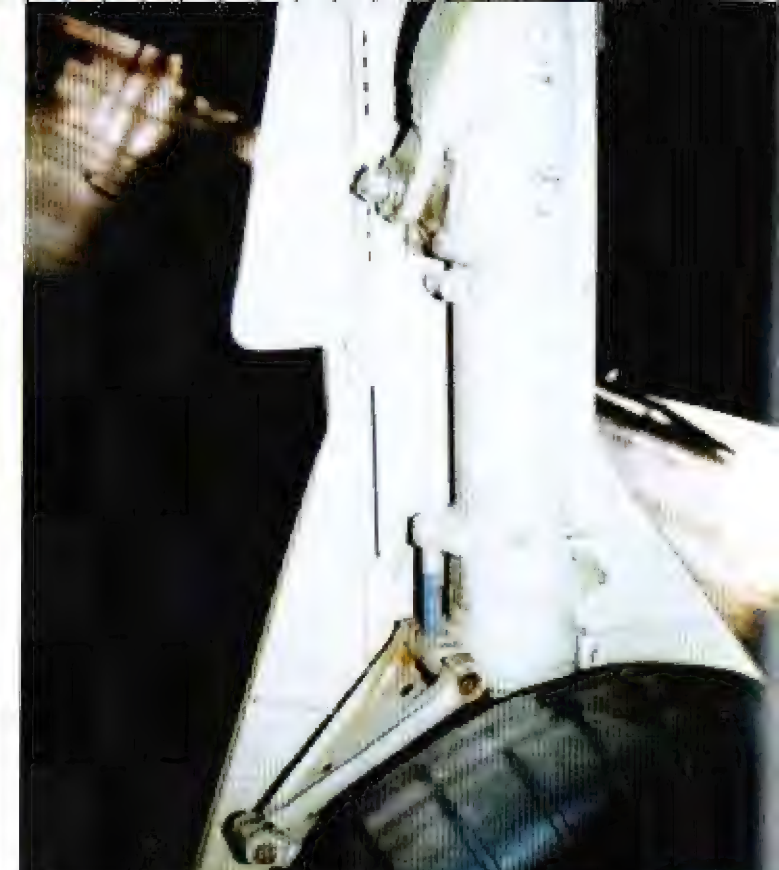
(Above and above right) The port landing gear from the front and from the rear. The landing gear of the Fw 190 did not extend straight down from the wing, but with a very pronounced inward angle. The landing gear extend/retract arms (upper and lower radius rods) are not over-centered but appear to have a slight bend. The landing gear like the wheel well is painted RLM 02. (Author: Ryle)

The extend/retract arm's attachment to the rear of the oleo shock strut on the port landing gear. The top of the scissors unit can be seen just above the wheel and immediately above that is the shock strut 'spur'. (Author: Ryle)

The starboard landing gear extend/retract arm. The wiring of the micro-switch may be seen as well as its plug-in on the rear wall of the wheel well. The tail wheel retract wire's attachment bolt is on the joint of the arm. (Author: Ryle)

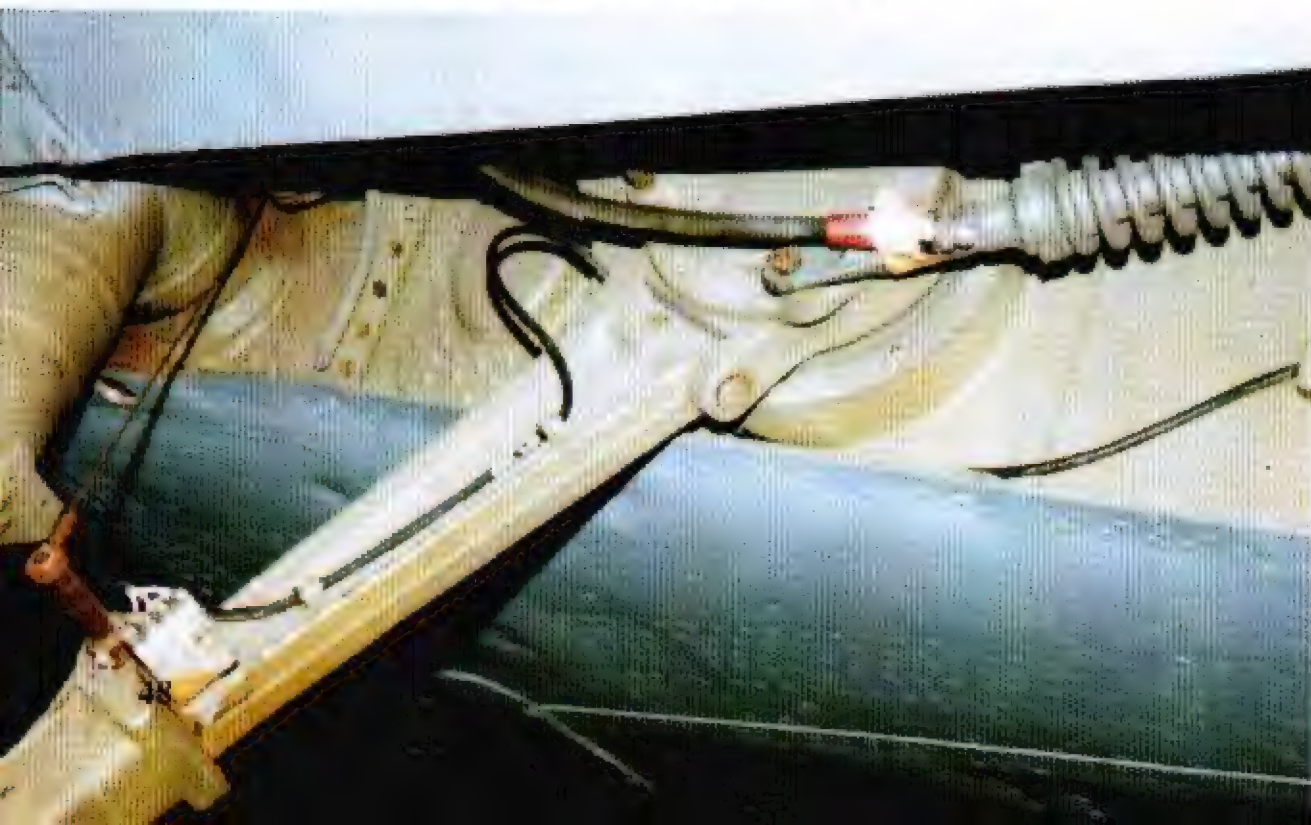
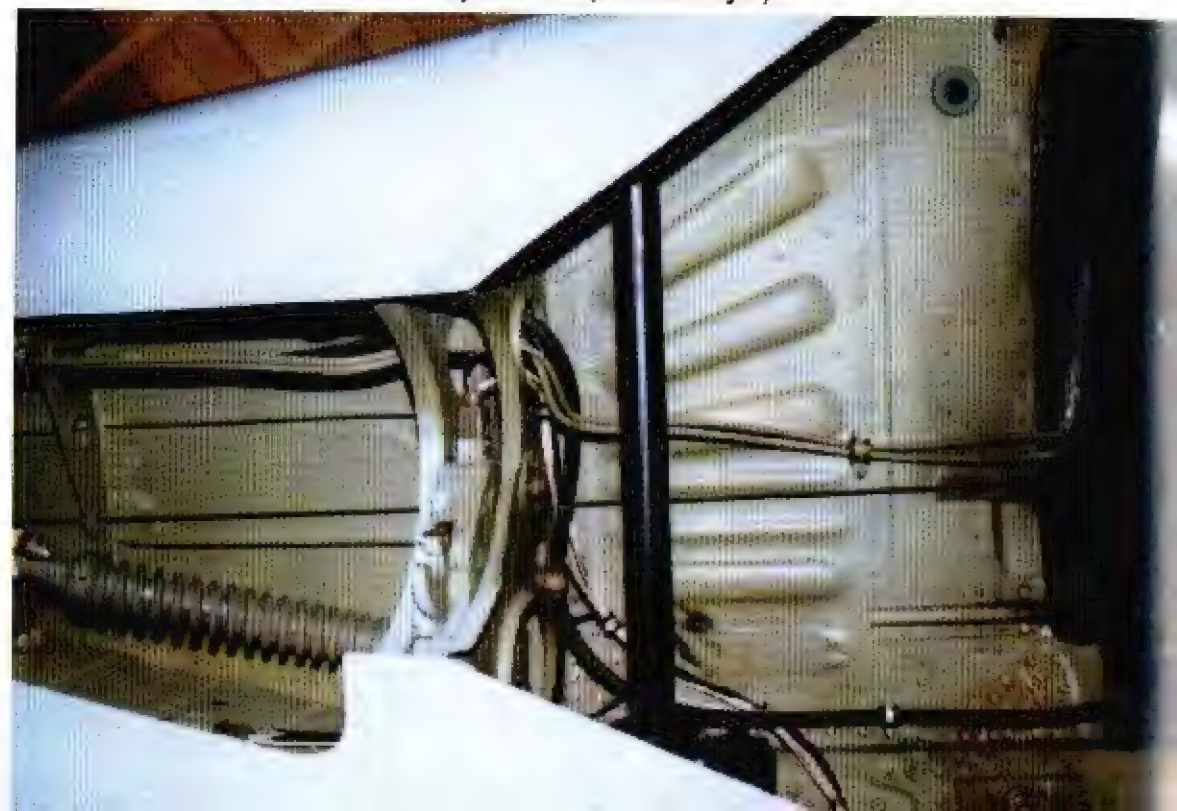
With the starboard under carriage down the rear of the engine can be seen. The 20mm cannon barrel can be seen (without a barrel shroud installed) as well as the inboard inner wing structure and landing gear up-lock assembly. The tail wheel retract wire runs through the center length of the wheel well to a pulley at the edge of the engine area. The wheel well is painted RLM 02 Gray-Green. (Author: Ryle)

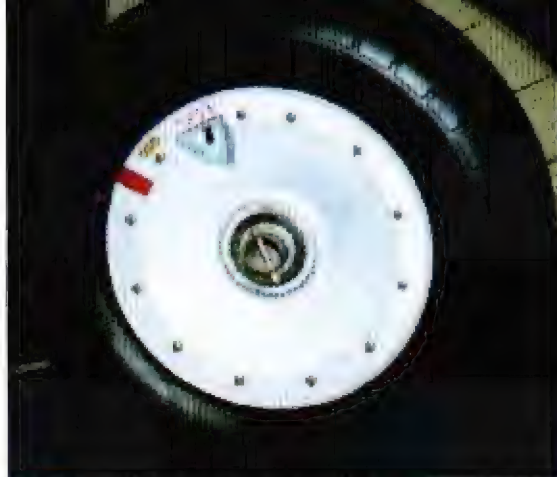
This late style wheel and tire are original. The wheel has a small yellow data tag between the red slip indicator and the triangular tire filler port. Most Fw 190 wheels were painted RLM 66 Black-Gray.
